## KB STARTING MOTORS

Thermoplastic-encapsulated terminals      ST 0438 En

ELECTRICAL  
CONNECTIONS

# N3 ALTERNATOR

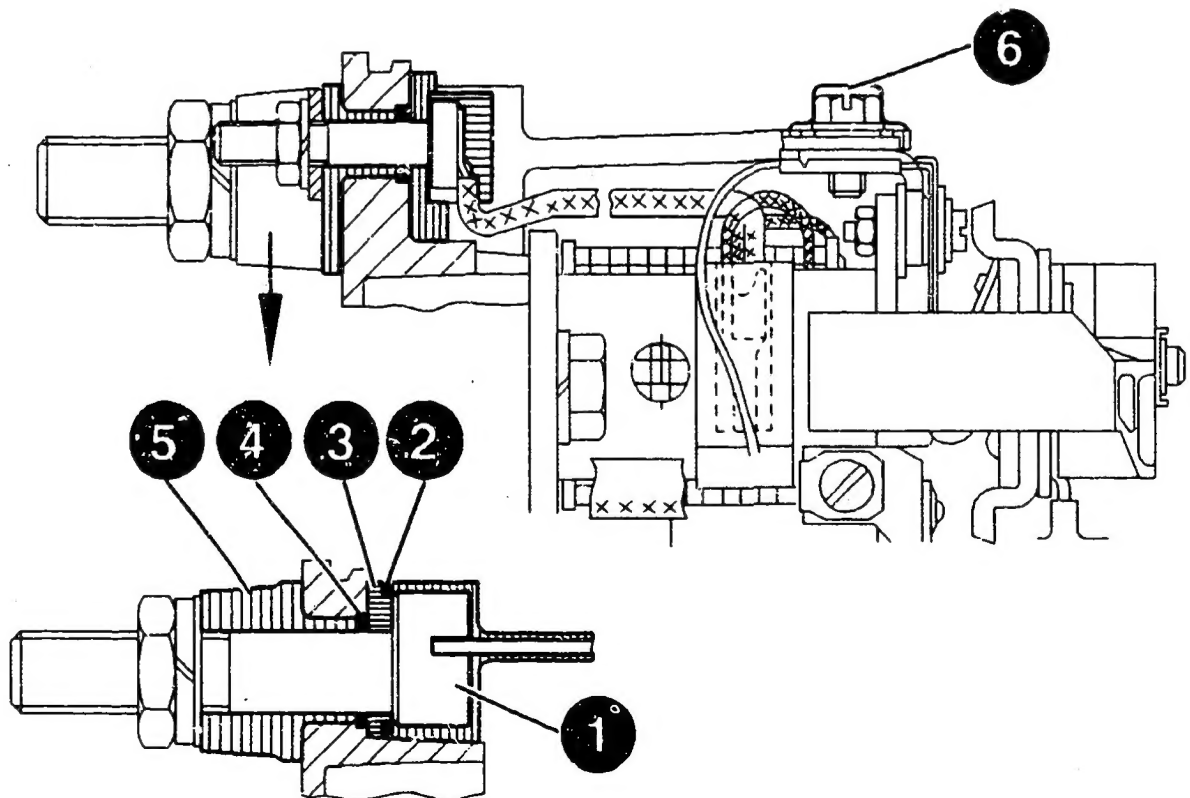
The new insulated version of term. 30 is shown at the bottom of the fig.

Following installation of new connecting bar term. 30 new insulating cap (6) must be fitted on hexagon bolt (term. 30).

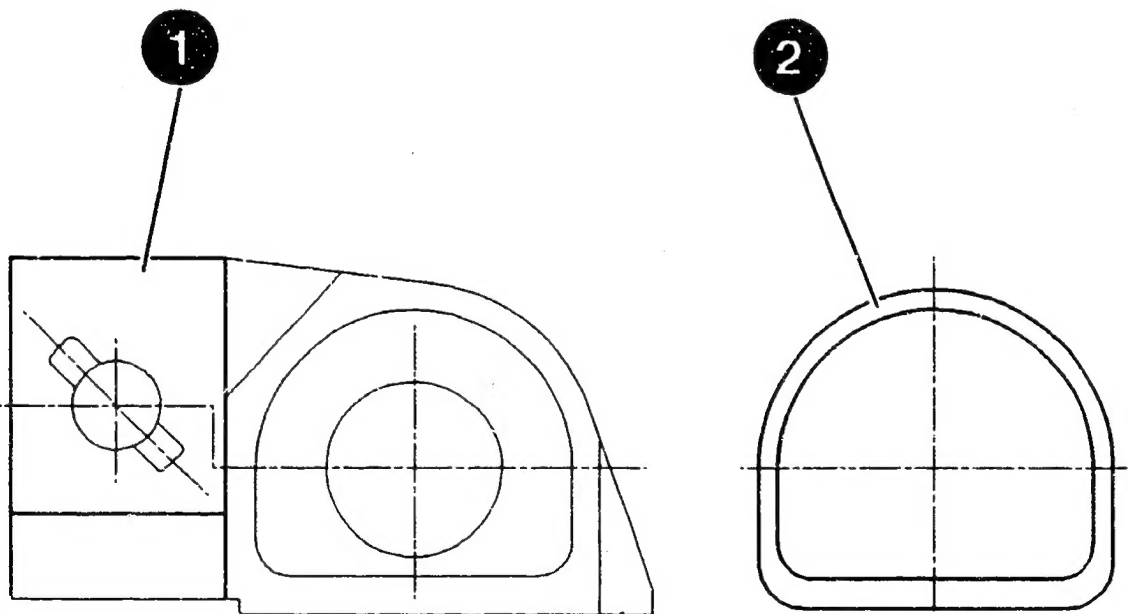
KMS00025

In the conversion phase as of FD 461, term. 30 was sealed on the inside by way of silicon encapsulation between connecting bar and inner insulating part.

When repairing such starting motors, use is to be made of the new insulating parts illustrated (in parts set term. 30, term. 31).

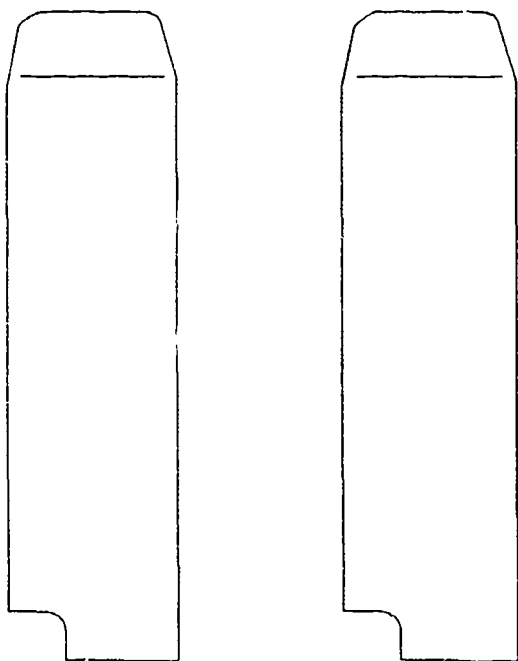
KKE01064

NO CONTACT MARKS (new)  
(see Fig.).

- No contact marks
- No appreciable dimensional or geometric errors on housing or plug section
- Plug pins not at an angle

Assessment:  
Plug pins OK.

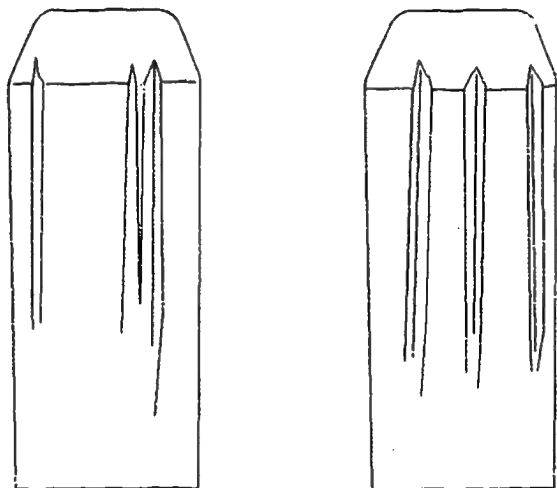
KKE01065

**NORMAL CONTACT MARKS**  
(see Fig.)

- Contact marks in center of plug pin
- Contact overlap (groove length on contact surface) more than 1 mm

Plug pins OK.

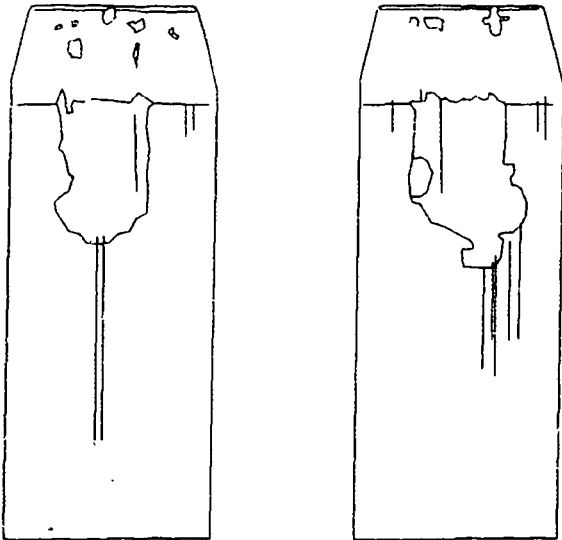
KKE01066

**MECHANICAL CONTACT MARKS**  
(see Fig.)

- Contact point damaged  
(scratched or scored)
- Pins bent (bent plugs due to  
inexpert handling of measurement  
prods)
- Partial flaking of tinned surface  
(indication of wear)

Plug pins not OK.

- \* Any attempt to eliminate contact problems with a brush or treatment with contact spray does not generally meet with lasting success. It is better to renew the contacts straight away.
- \* Component and wiring-harness plug must have the same surface finish: Either both tinned or both gold-plated.

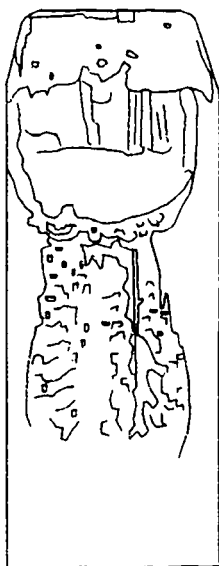
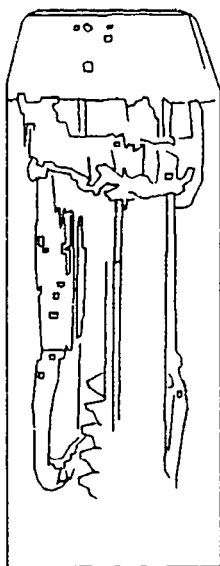
KKE01067

**OXIDIZED CONTACT MARKS**  
(see Fig.)

- Severe oxidization of contact point, oxidation residue (e.g. tin oxide)
- Friction corrosion
- Surface finish worn down to substrate

**Plug pins not OK.**

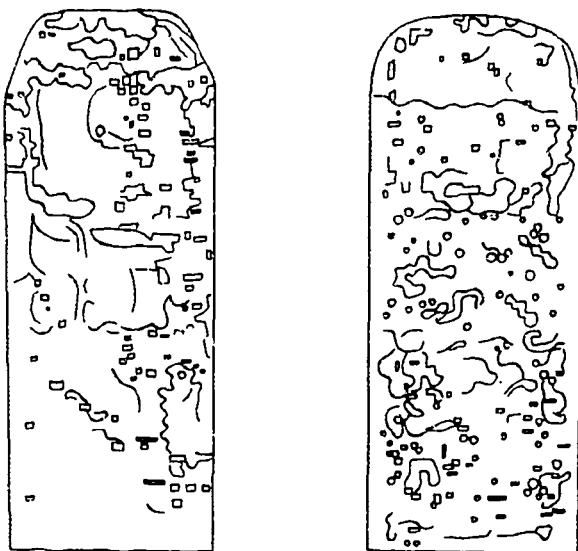
KKE01068

**THERMAL CONTACT MARKS**  
(see Fig.)

- Contact scorched
- Contact surface discolored due to overheating

Plug pins not OK.

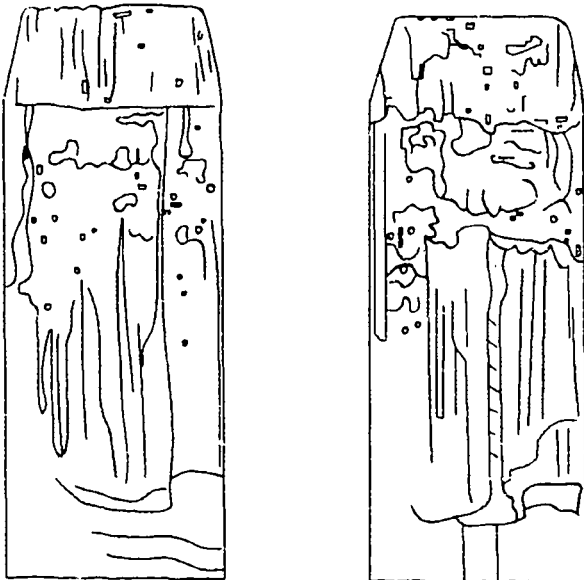
KKE01069

**DEPOSITS**  
(see Fig.)

- Deposits and condensates on plug pins
- Residue on plug pins
- Plug pins covered with lacquer for example
- Contact point partially corroded
- Loose particles (dust, dirt etc.) on plug or contact

Plug pins not OK, leaky connection.
